PROYECTO FINAL DE CARRERA

Patología estructural y del casco:

Métodos de protección, inspección, mantenimiento y reparación

Ingeniería Naval y Oceánica
Junio, 2014

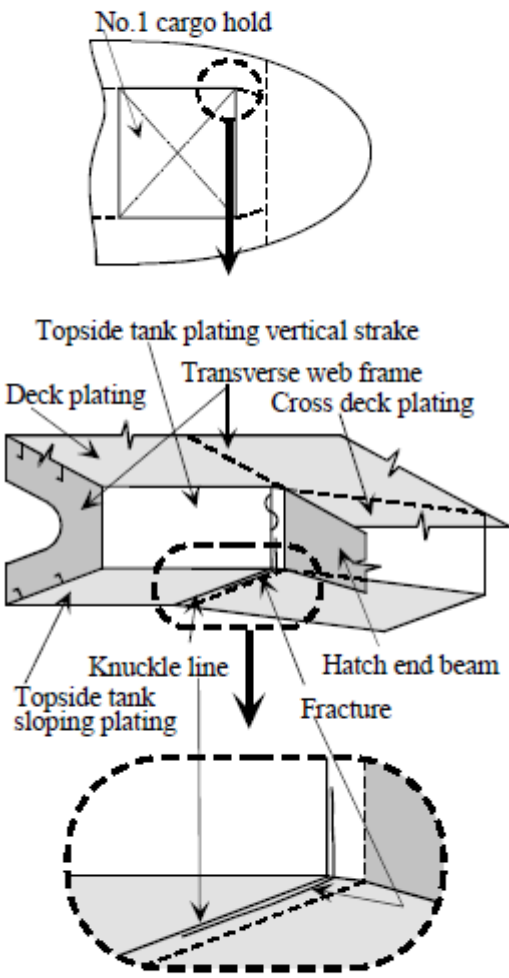
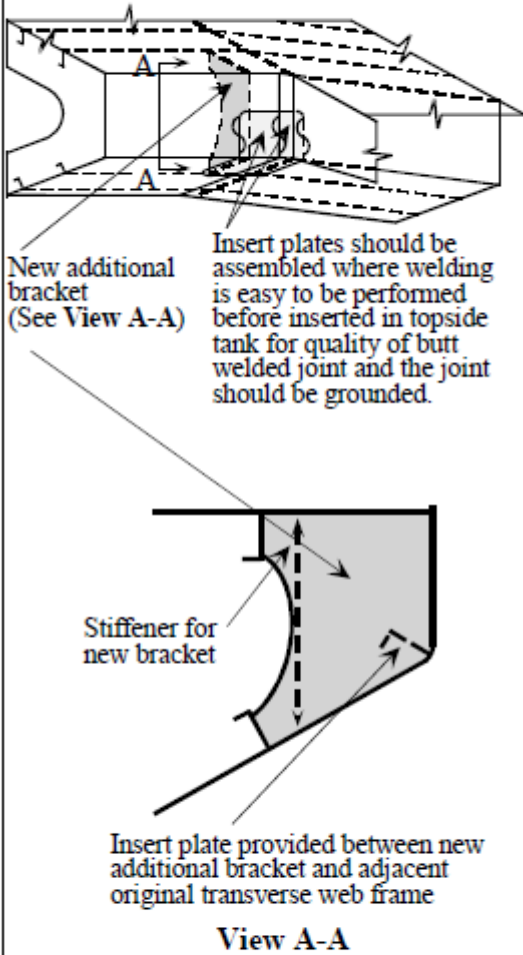
BULK CARRIERS		Guidelines for Surveys, Assessment and Repair of Hull Structure
Part 1	Cargo hold region	Example No.
Area 2	Topside tank structure	9
Detail of damage		Fractures in sloping plating at knuckle
Sketch of damage		Sketch of repair

<p>No.1 cargo hold</p> <p>Topside tank plating vertical strake</p> <p>Deck plating</p> <p>Transverse web frame</p> <p>Cross deck plating</p> <p>Knuckle line</p> <p>Hatch end beam</p> <p>Topside tank sloping plating</p> <p>Fracture</p>

<p>New additional bracket (See View A-A)</p> <p>Insert plates should be assembled where welding is easy to be performed before inserted in topside tank for quality of butt welded joint and the joint should be grounded.</p> <p>Stiffener for new bracket</p> <p>Insert plate provided between new additional bracket and adjacent original transverse web frame</p> <p>View A-A</p>
Notes on possible cause of damage		Notes on repairs

<ol style="list-style-type: none"> 1. Insufficient strength. 2. Additional stress induced by knuckle. 		<ol style="list-style-type: none"> 1. Knuckle part should be reinforced appropriately.

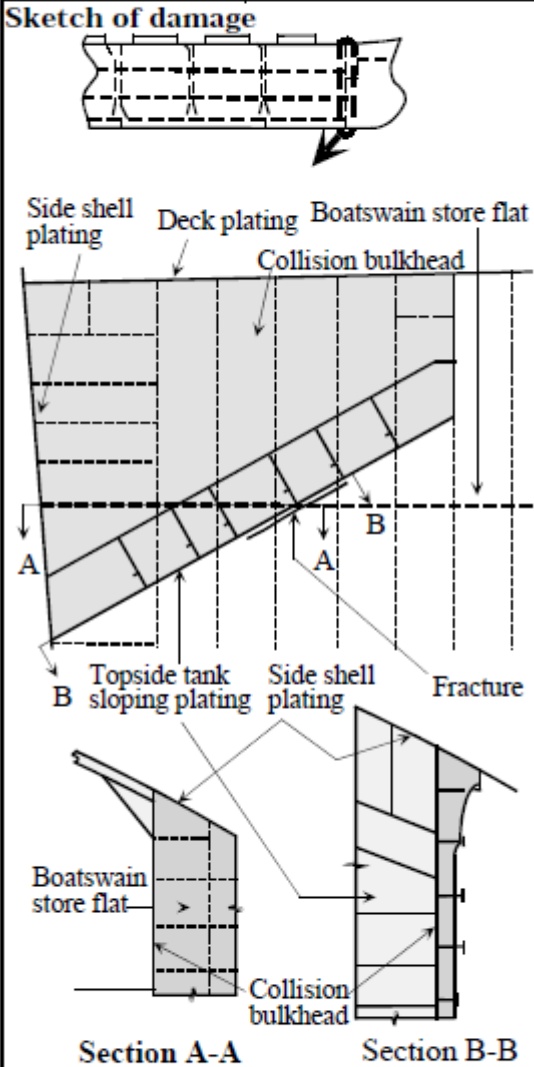
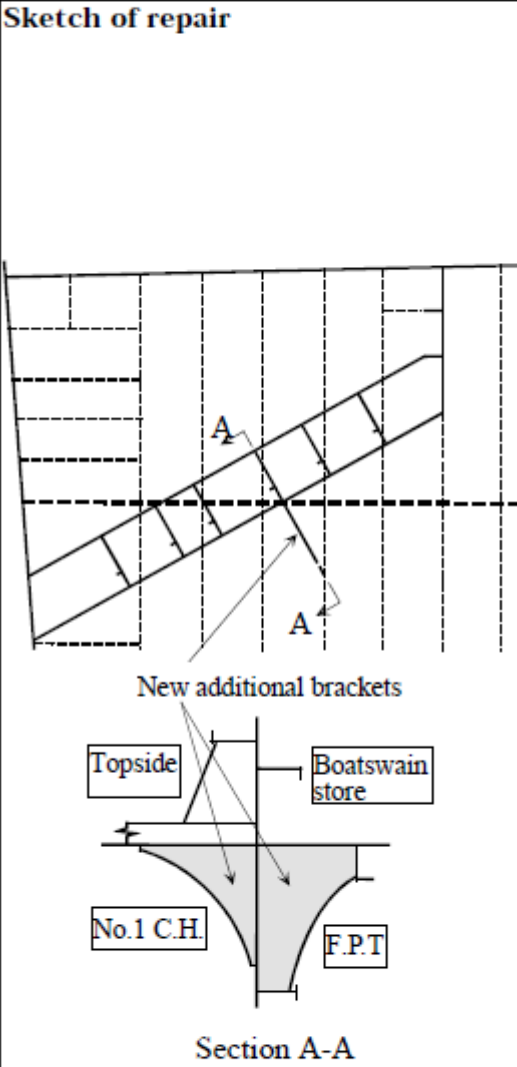
<p>Side shell plating Deck plating Boatswain store flat Collision bulkhead</p> <p>Topside tank sloping plating Side shell plating Fracture Boatswain store flat Collision bulkhead</p> <p>Section A-A Section B-B</p>

<p>New additional brackets</p> <p>Topside Boatswain store No.1 C.H. F.P.T.</p> <p>Section A-A</p>
Notes on possible cause of damage 1. Damage caused by hard spot at intersection of the topside tank sloping plating and boatswain's store deck plating (fore peak tank top plating).		Notes on repairs 1. Fractured plates to be cropped and renewed. 2. Stress concentration should be considered (Brackets were fitted on both sides for reinforcement).

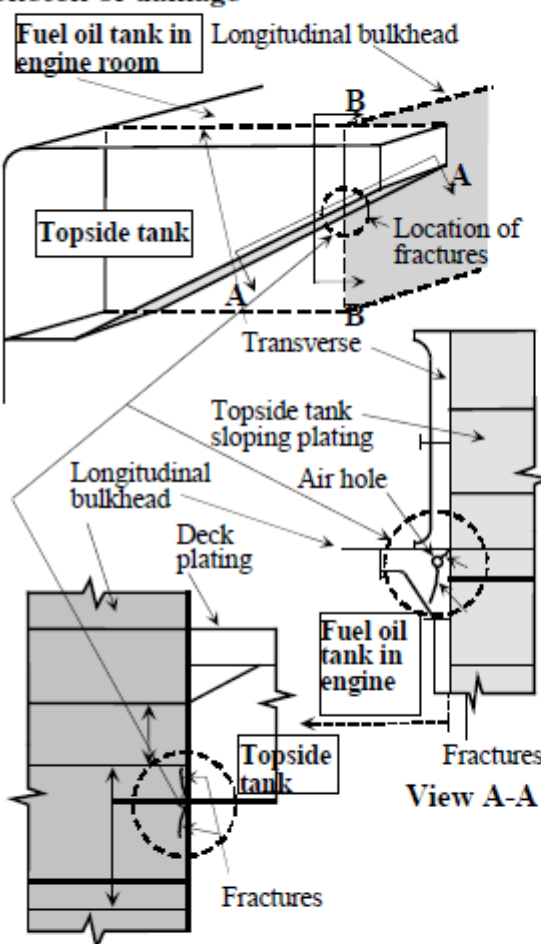
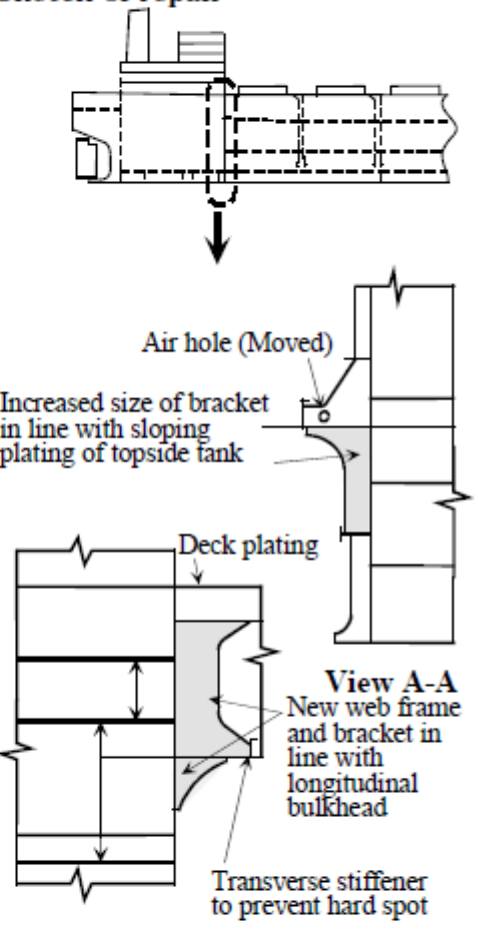
<p>Fuel oil tank in engine room</p> <p>Longitudinal bulkhead</p> <p>Topside tank</p> <p>Location of fractures</p> <p>Transverse</p> <p>Topside tank sloping plating</p> <p>Longitudinal bulkhead</p> <p>Deck plating</p> <p>Air hole</p> <p>Fuel oil tank in engine</p> <p>Topside tank</p> <p>Fractures</p> <p>View A-A</p>

<p>Air hole (Moved)</p> <p>Increased size of bracket in line with sloping plating of topside tank</p> <p>Deck plating</p> <p>View A-A</p> <p>New web frame and bracket in line with longitudinal bulkhead</p> <p>Transverse stiffener to prevent hard spot</p>
Notes on possible cause of damage		Notes on repairs

1. Damage caused by hard spot at intersection of the topside tank sloping plating and longitudinal bulkhead of the fuel oil tank in engine room.		1. Fractured plates to be cropped and renewed as necessary and reinforcement fitted as shown shaded above. The position of the air-hole to be relocated.

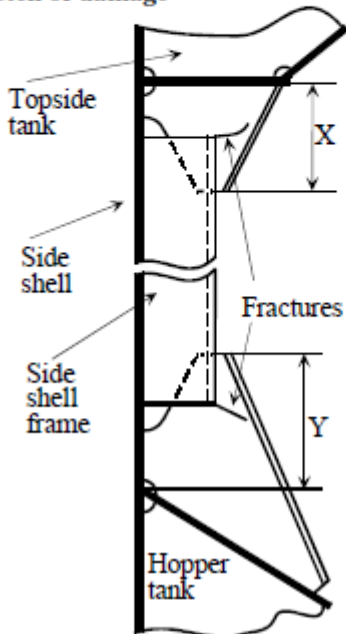
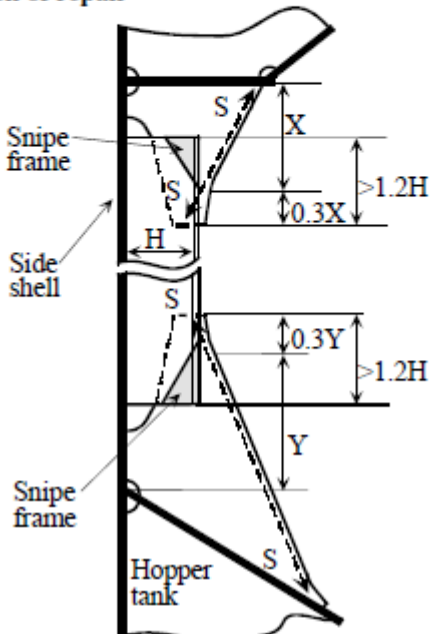
BULK CARRIERS		Guidelines for Surveys, Assessment and Repair of Hull Structure	
Part 1	Cargo hold region	Example No.	
Area 3	Cargo hold side structure	1-a	
Detail of damage		Fractures in brackets at termination of frame	
Sketch of damage		Sketch of repair

<p>Separate bracket configuration</p>

<p>S=Snipped end</p>	
Notes on possible cause of damage		Notes on repairs	
<p>1. This type of damage is caused due to stress concentration.</p>		<p>1. For small fractures, e. g. hairline fractures, the fracture can be veed-out, ground, examined by NDT for fractures, and rewelded.</p> <p>2. For larger/significant fractures consideration is to be given to cropping and partly renewing/ renewing the frame brackets. If renewing the brackets, end of frames can be sniped to soften them.</p> <p>3. If felt prudent, soft toes are to be incorporated at the boundaries of the bracket to the hopper plating.</p> <p>4. Attention to be given to the structure in wing tanks in way of the extended bracket arm. i.e. reinforcement provided in line with the bracket.</p>

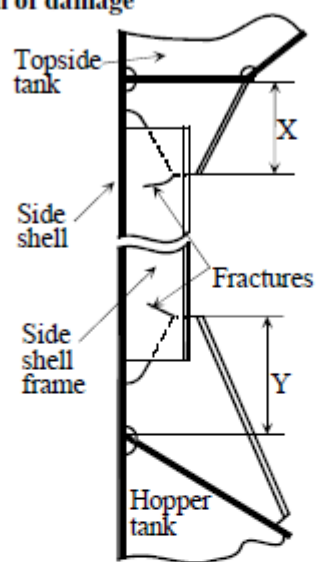
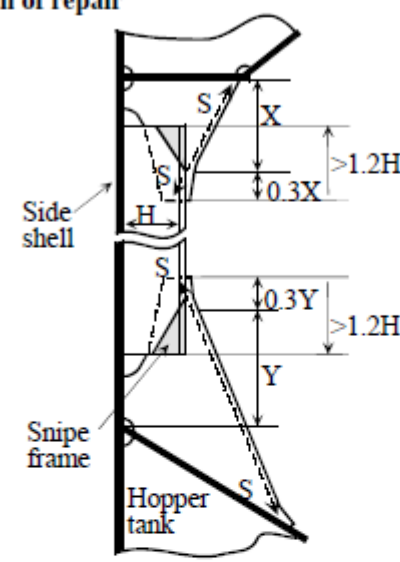
BULK CARRIERS		Guidelines for Surveys, Assessment and Repair of Hull Structure	
Part 1	Cargo hold region	Example No.	
Area 3	Cargo hold side structure	1-b	
Detail of damage		Fractures in side shell frame at bracket's toe	
Sketch of damage		Sketch of repair

<p>Separate bracket configuration</p>

<p>S=Snipped end</p>	
Notes on possible cause of damage		Notes on repairs	
<p>1. This type of damage is caused due to stress concentration.</p>		<p>1. For small fractures, e. g. hairline fractures, the fracture can be veed-out, welded up, ground, examined by NDT for fractures, and rewelded.</p> <p>2. For larger/significant fractures consideration is to be given to cropping and partly renewing/ renewing the frame brackets. If renewing the brackets, end of frames can be sniped to soften them.</p> <p>3. If felt prudent, soft toes are to be incorporated at the boundaries of the bracket to the hopper plating.</p> <p>4. Attention to be given to the structure in wing tanks in way of the extended bracket arm. i.e. reinforcement provided in line with the bracket.</p>

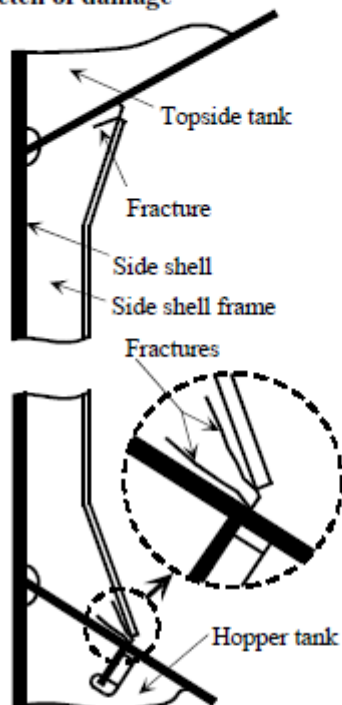
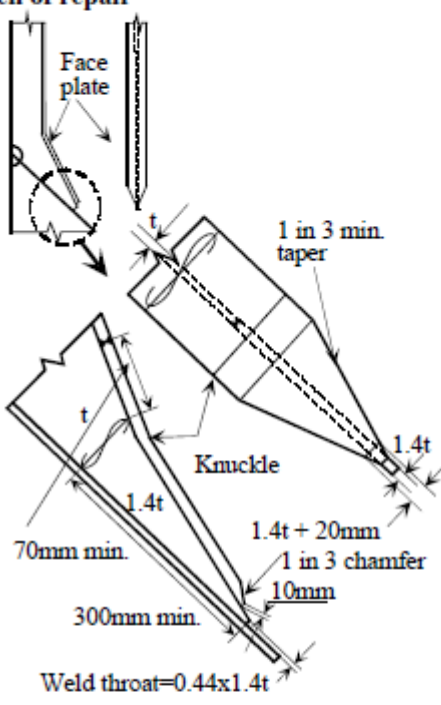
BULK CARRIERS		Guidelines for Surveys, Assessment and Repair of Hull Structure	
Part 1	Cargo hold region	Example No.	
Area 3	Cargo hold side structure	2	
Detail of damage		Fractures in side shell frame at bracket's toe	
Sketch of damage		Sketch of repair

Notes on possible cause of damage		Notes on repairs	
<p>1. This type of damage is caused due to stress concentration.</p>		<p>1. Repair is to incorporate a design similar to the one shown on the sketch and in addition:-</p> <p>1.1. The arm of the bracket along the hopper/ topside plating should be increased by altering the angle of the bracket face plate. A face plate taper of 1 in 3 should be arranged.</p> <p>1.2. The local thickness of the bracket web plating over the length of the new face plate taper should be increased by about 40% above that originally fitted.</p> <p>1.3. The face plate thickness should be chamfered 1 in 3 to a thickness at its extremity.</p> <p>1.4. Welding of the new bracket toe should be based on a weld factor of 0.44 applied to the increased thickness.</p> <p>2. Attention to be given to the structure in wing tanks in way of the extended bracket arm. I.e. reinforcement provided in line with the bracket.</p>

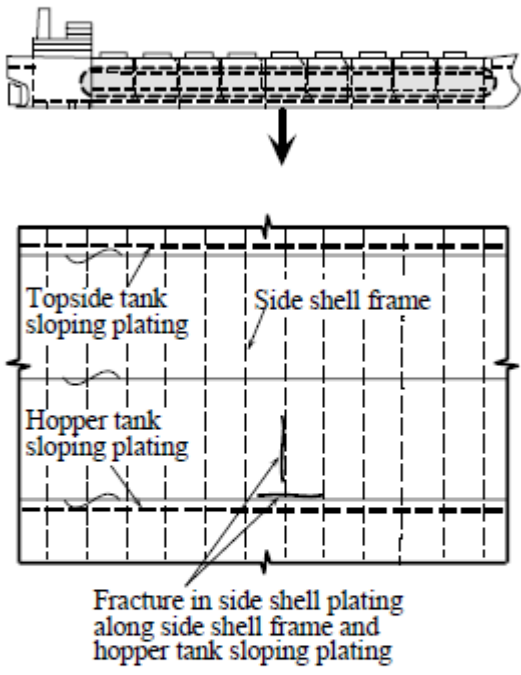
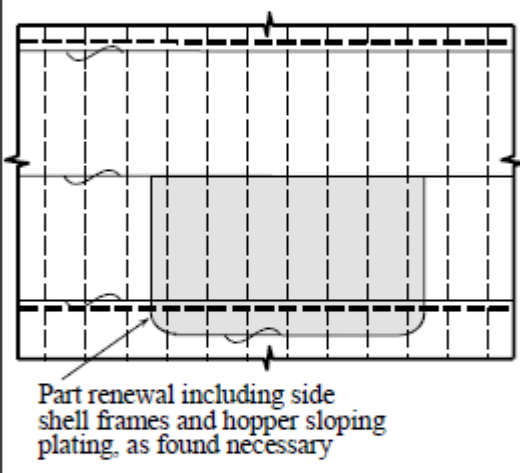
BULK CARRIERS		Guidelines for Surveys, Assessment and Repair of Hull Structure	
Part 1	Cargo hold region	Example No.	
Area 3	Cargo hold side structure	3	
Detail of damage		Fractures in side shell frame/lower bracket and side shell plating near hopper	
Sketch of damage		Sketch of repair

<p>Topside tank sloping plating</p> <p>Side shell frame</p> <p>Hopper tank sloping plating</p> <p>Fracture in side shell plating along side shell frame and hopper tank sloping plating</p>

<p>Part renewal including side shell frames and hopper sloping plating, as found necessary</p>	
Notes on possible cause of damage		Notes on repairs	
<ol style="list-style-type: none"> 1. Heavy corrosion (grooving). Refer to Figure 2 (c). 		<ol style="list-style-type: none"> 1. Sketch of repair applies when damage extends over several frames. 2. Isolated fractures may be repaired by veeing-out and rewelding. 3. Isolated cases of grooving may be repaired by build up of welding.

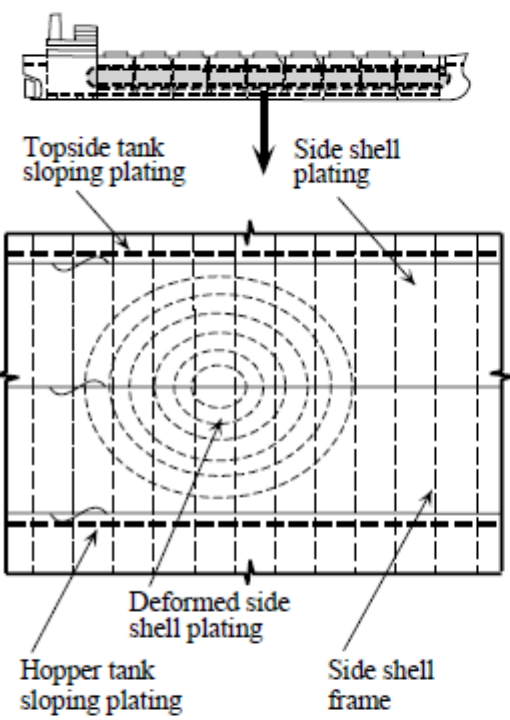
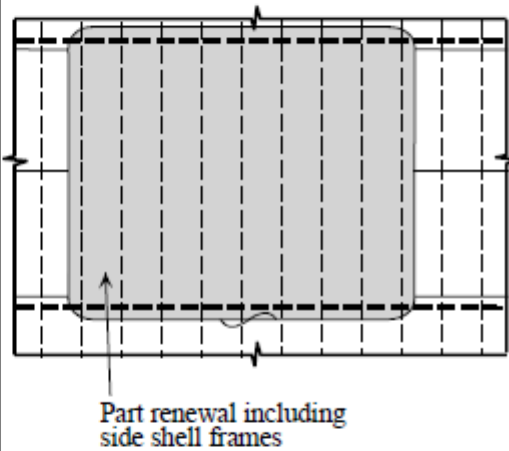
BULK CARRIERS		Guidelines for Surveys, Assessment and Repair of Hull Structure
Part 1	Cargo hold region	Example No.
Area 3	Cargo hold side structure	4
Detail of damage		Deformation of side shell plating
Sketch of damage		Sketch of repair

Notes on possible cause of damage		Notes on repairs
<ol style="list-style-type: none"> 1. Insufficient stiffness of side shell frames due to buckling and/or detachment of side shell frames due to corrosion. 2. Heavy weather. 		<ol style="list-style-type: none"> 1. Deformed side shell plating including side shell frames should be cropped and renewed.

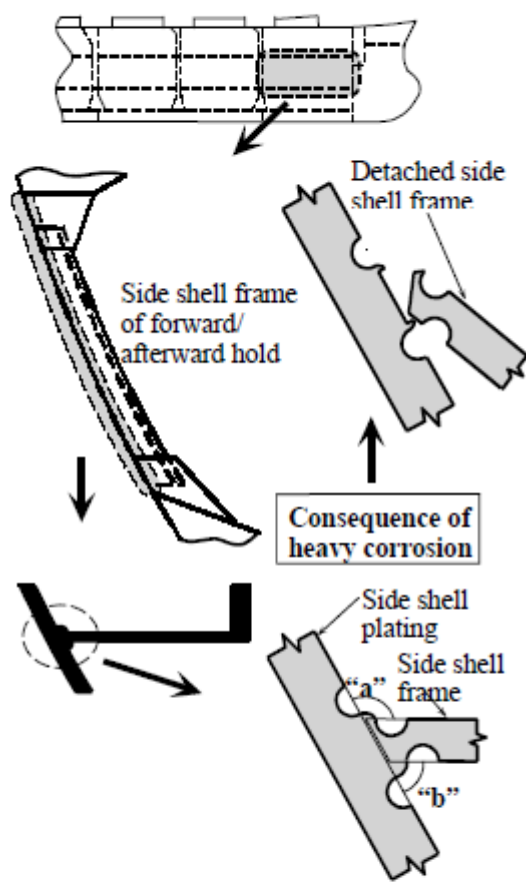
BULK CARRIERS		Guidelines for Surveys, Assessment and Repair of Hull Structure
Part 1	Cargo hold region	Example No.
Area 3	Cargo hold side structure	5
Detail of damage	Adverse effect of corrosion on the frame of forward/afterward hold	
Sketch of damage		Sketch of repair

<p>Detached side shell frame</p> <p>Side shell frame of forward/afterward hold</p> <p>Consequence of heavy corrosion</p> <p>Side shell plating</p> <p>Side shell frame</p> <p>"a"</p> <p>"b"</p>

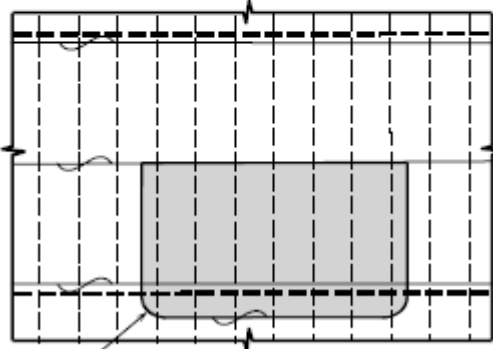
<ol style="list-style-type: none"> 1. Part renewal including side shell frames and hopper plating, as found necessary 2. Deep penetration welding at the connections of side shell frames to side shell plating
Notes on possible cause of damage <ol style="list-style-type: none"> 1. Heavy corrosion (grooving) of side shell frame along side shell plating and difference of throat thickness "a" from "b". (Since original throat thickness of "a" is usually smaller than that of "b", if same welding procedure is applied, the same corrosion has a more severe effect on "a", and may cause collapse and/or detachment of side shell frame.) 		Notes on repairs <ol style="list-style-type: none"> 1. Sketch of repair applies when damage extends over several frames. 2. Isolated fractures may be repaired by veeing-out and rewelding. 3. Isolated cases of grooving may be repaired by build up of welding.

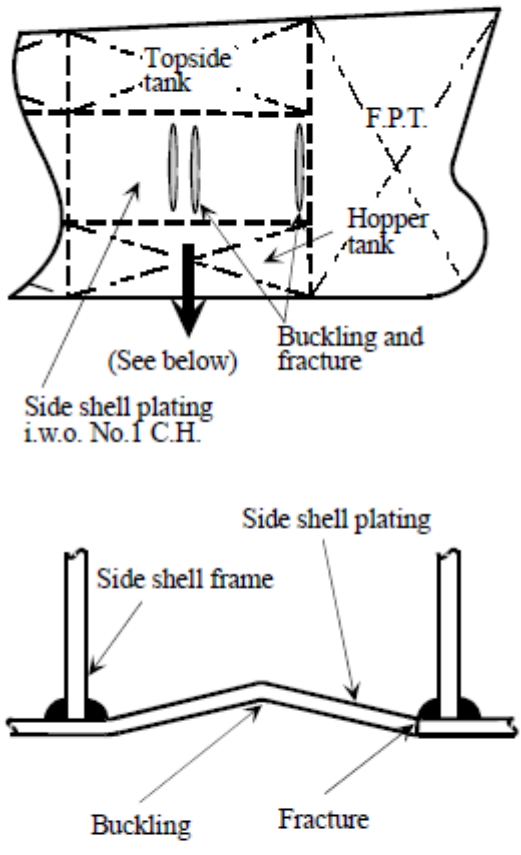
BULK CARRIERS		Guidelines for Surveys, Assessment and Repair of Hull Structure
Part 1	Cargo hold region	Example No.
Area 3	Cargo hold side structure	6
Detail of damage	Buckling and fractures of side shell plating in foremost cargo hold	
Sketch of damage		Sketch of repair

<p>Topside tank</p> <p>F.P.T.</p> <p>Hopper tank</p> <p>(See below)</p> <p>Buckling and fracture</p> <p>Side shell plating i.w.o. No.1 C.H.</p> <p>Side shell frame</p> <p>Side shell plating</p> <p>Buckling</p> <p>Fracture</p>

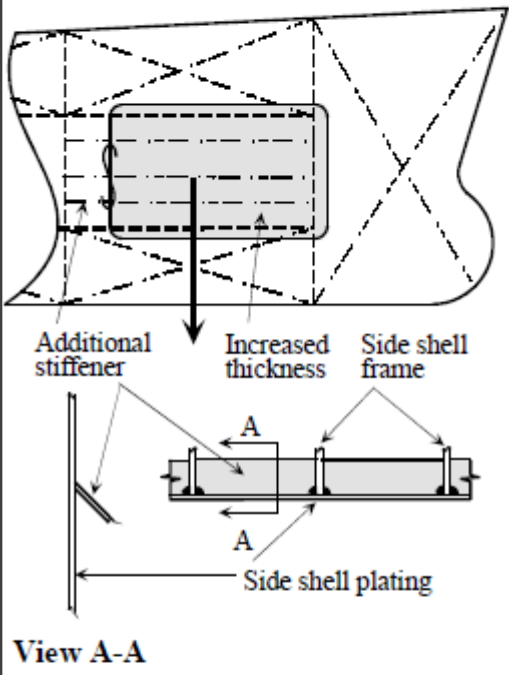
<p>Additional stiffener</p> <p>Increased thickness</p> <p>Side shell frame</p> <p>Side shell plating</p> <p>View A-A</p>
Notes on possible cause of damage <ol style="list-style-type: none"> 1. Heavy weather. 2. Insufficient buckling strength due to high tensile steel or heavy uniform corrosion. 3. Inadequate transition structure. 		Notes on repairs <ol style="list-style-type: none"> 1. Buckled/fractured side shell plating is to be cropped and renewed. 2. Reinforcement by thicker side shell plating and/or additional stiffeners should be considered.

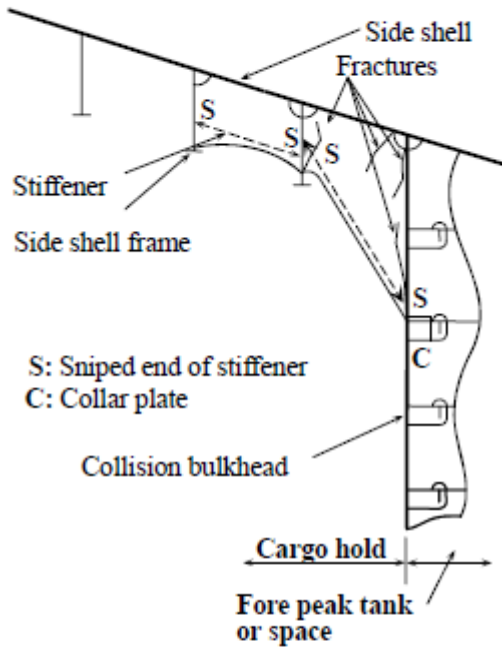
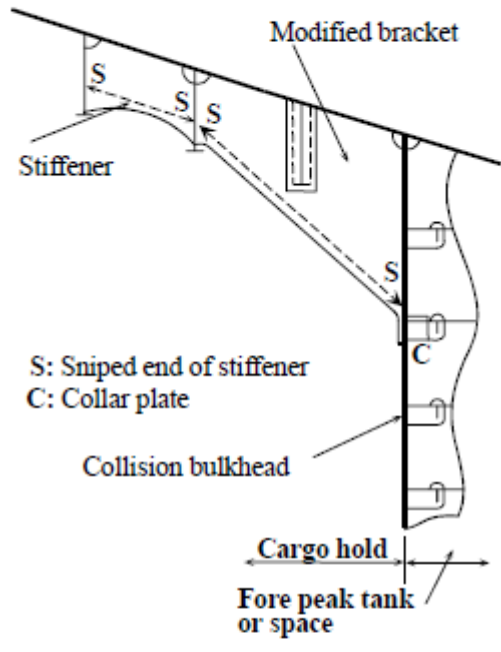
BULK CARRIERS		Guidelines for Surveys, Assessment and Repair of Hull Structure	
Part 1	Cargo hold region	Example No.	
Area 3	Cargo hold side structure	7	
Detail of damage		Fractures at the supporting brackets in way of the collision bulkhead	
Sketch of damage		Sketch of repair

Notes on possible cause of damage		Notes on repairs	
<ol style="list-style-type: none">1. Insufficient bracket size resulting in high stress due to load cantilevered from side frame.2. Stress concentration at toe of bracket and misalignment between bracket and stringer in fore peak tank or space.		<ol style="list-style-type: none">1. The extended bracket arm connection to the collision bulkhead is to have a soft toe, and any cut-outs for stiffeners in the fore peak tank or space are to be collared when situated in the vicinity of the bracket toe.2. When fractures have extended into the side shell or bulkhead plating, the plating is to be cropped and part renewed.

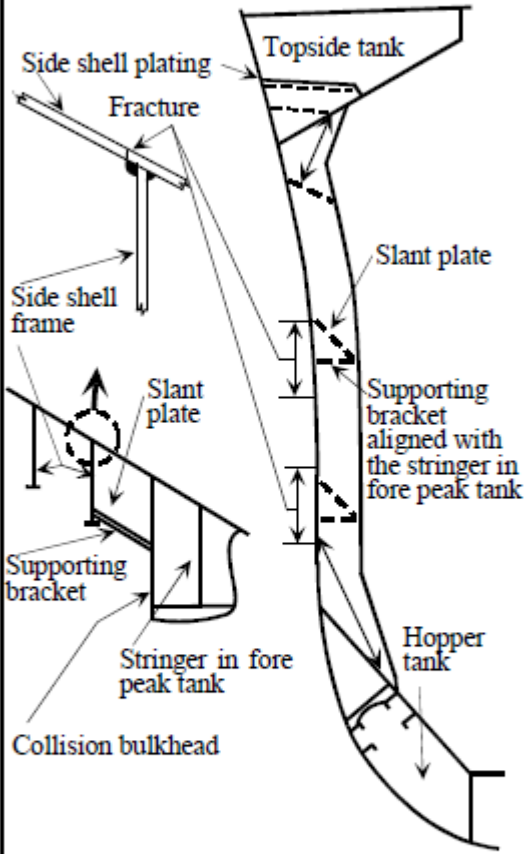
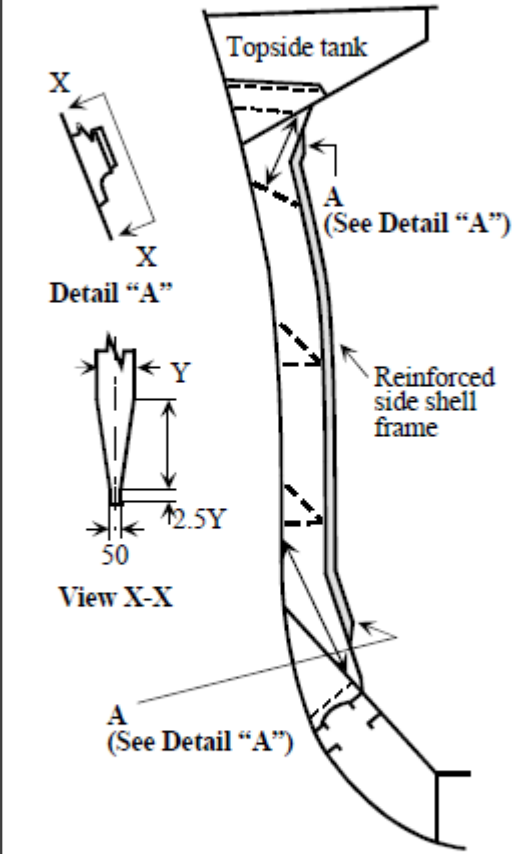
Notes on possible cause of damage 1. Damage caused by stress concentration leading to fatigue fracture in side shell. This has been exacerbated because of the greater flexibility of the hold structure in relation to the structure forward of the collision bulkhead.		Notes on repairs 1. Fractured shell plates to be cropped and part renewed, and side shell frame/frames in the vicinity of the damage to be reinforced as required by the relevant Classification Society.

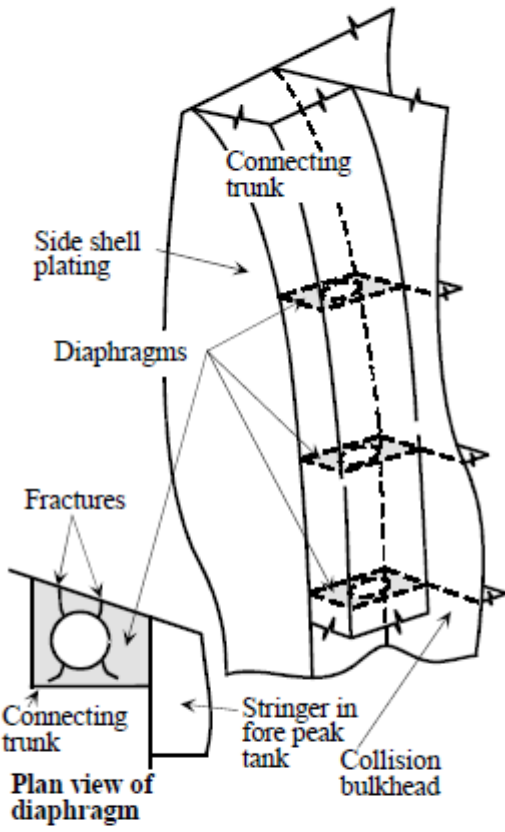
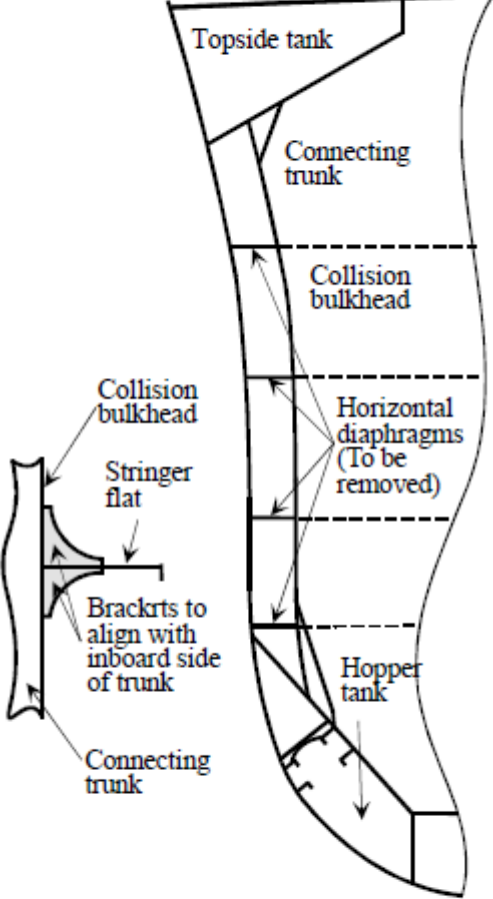
Notes on possible cause of damage 1. Damage caused by stress concentration resulting from the discontinuity created by the trunk and diaphragm structure. This has been exacerbated because of the greater flexibility of the hold structure in relation to the trunk and structure forward of the collision bulkhead.		Notes on repairs 1. Diaphragm to be removed permanently and fractured shell plated cropped and part renewed, or veed and weld as necessary in way of damage. Brackets with softened toes are to be fitted on forward side of collision bulkhead in way of stringers/flats to align with inboard side of trunk in order to remove hard-spots.

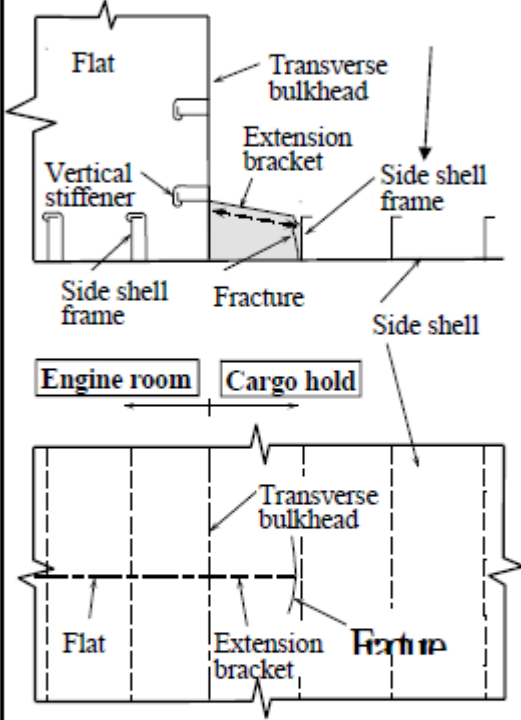
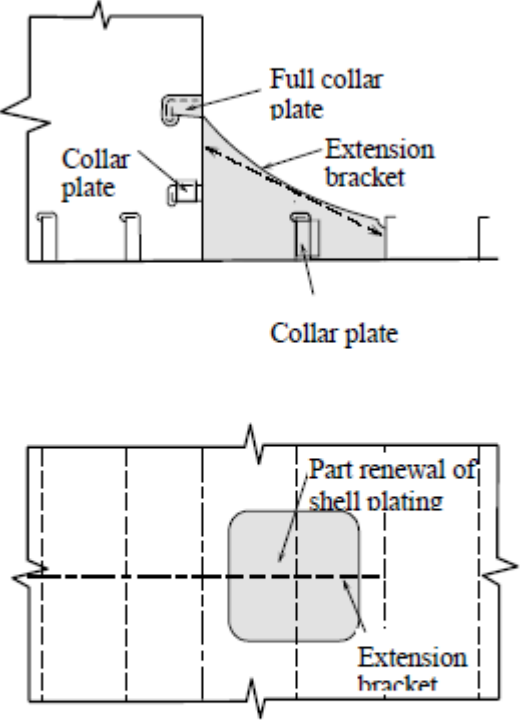
Notes on possible cause of damage		Notes on repairs
<ol style="list-style-type: none"> 1. Damage caused by stress concentration leading to fatigue fracture on side shell. This will be exacerbated because of the greater flexibility of the hold structure in relation to the engine room structure. 		<ol style="list-style-type: none"> 1. The fractured shell plating is to be cropped and part renewed as necessary. 2. Extension bracket is to be modified and collar plates to cut-outs in engine room flat are to be installed.

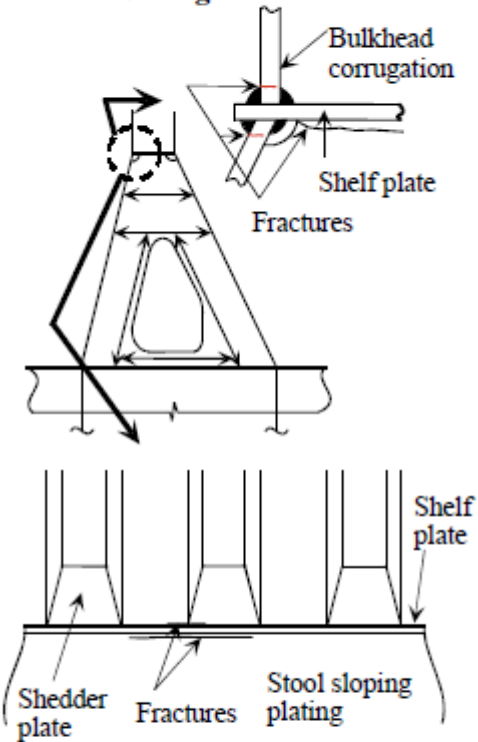
BULK CARRIERS		Guidelines for Surveys, Assessment and Repair of Hull Structure
Part 1	Cargo hold region	Example No.
Area 4	Transverse bulkhead and associated structure in cargo hold	1-a
Detail of damage		Fractures at weld connections to stool shelf plate
Sketch of damage		Sketch of repair

<p>The sketch of damage consists of two parts. The top part is a perspective view of a bulkhead corrugation connected to a shelf plate. Arrows point to 'Bulkhead corrugation', 'Shelf plate', and 'Fractures' at the weld line. The bottom part is a plan view showing 'Shedder plate', 'Fractures', and 'Stool sloping plating' connected to a 'Shelf plate'.</p>

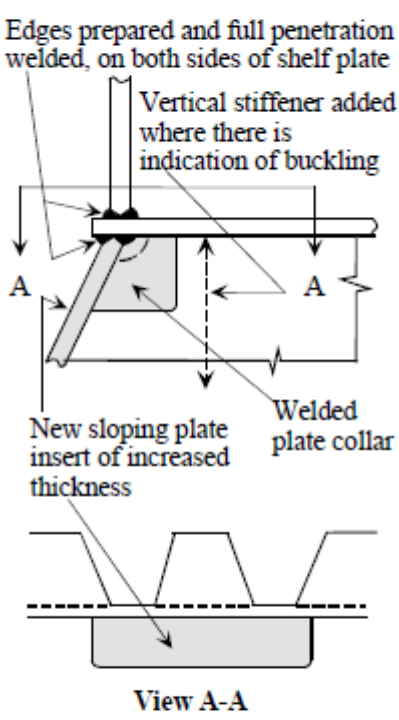
<p>The sketch of repair consists of two parts. The top part is a perspective view showing 'Edges prepared and full penetration welded, on both sides of shelf plate', a 'Vertical stiffener added where there is indication of buckling', a 'New sloping plate insert of increased thickness', and a 'Welded plate collar'. Section lines 'A-A' are indicated. The bottom part is 'View A-A', a cross-section showing the repair details.</p>

Notes on possible cause of damage		Notes on repairs
<ol style="list-style-type: none"> 1. Stress concentrations at welds adjacent to the scallops. 2. Inadequate welding area connecting corrugation flange to shelf plate or similarly sloping stool plating to shelf plate. 3. Inadequate thickness of sloping plating in relation to corrugation flange thickness. 4. Stress concentration at knuckle of corrugation where web is not supported by bracket inside the stool. 		<ol style="list-style-type: none"> 1. Fractures to be veed-out and rewelded. 2. Reductions in stress concentration by fitting welded plate collars in way of the scallop. 3. Where necessary an insert plate to be arranged in stool plating and/or diaphragm.

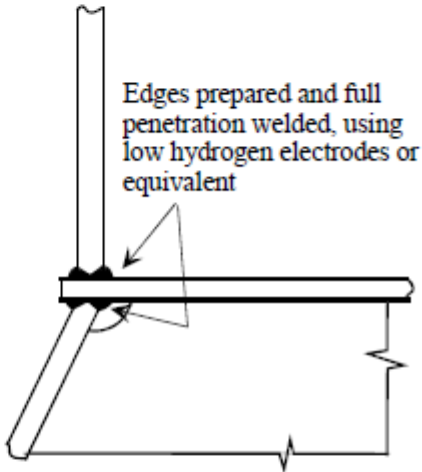
Sketch of repair

Notes on possible cause of damage <ol style="list-style-type: none"> 1. Misalignment between corrugation flange and sloping stool plating. 2. Inadequate welding area connecting corrugation flange to shelf plate or similarly sloping stool plating to shelf plate. 		Notes on repairs <ol style="list-style-type: none"> 1. Fractures to be veed-out and rewelded. 2. Structure to be released and misalignment rectified. 3. Edge of the corrugated bulkhead and the stool plating on both sides of shelf plate to have full penetration welds. 4. Where necessary an insert plate to be arranged in stool plating.

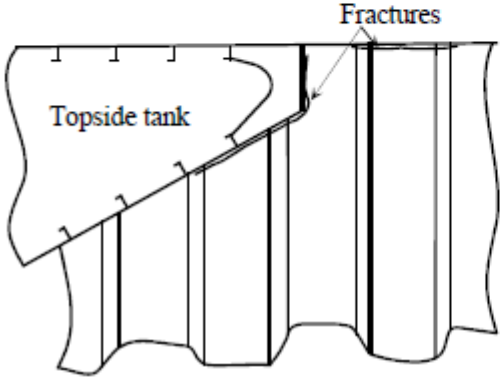
BULK CARRIERS		Guidelines for Surveys, Assessment and Repair of Hull Structure
Part 1	Cargo hold region	Example No.
Area 4	Transverse bulkhead and associated structure in cargo hold	2
Detail of damage		Fractures at the upper boundaries to topside tanks
Sketch of damage		Sketch of repair

<p>The diagram shows a cross-section of a ship's hull. A 'Topside tank' is labeled on the left. To its right, a vertical structure is shown with several vertical lines indicating 'Fractures' at the upper boundaries where it meets the topside tank.</p>		<p>Continuous or intercostal reinforcement in line with flanges or gussets where not already fitted</p> <p>Adjacent to the topside tank either a gusset to a bulb plate stiffener may be</p>

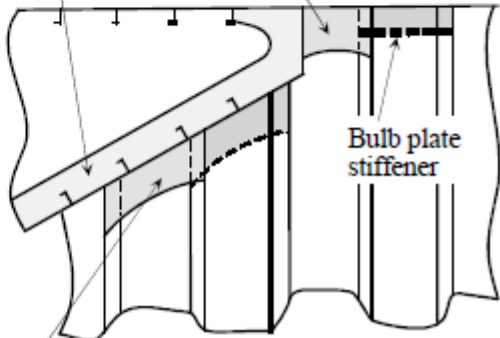
<p>Bulb plate stiffener</p> <p>Gusset(similar gusset on the opposite</p> <p>The repair sketch shows the same hull section as the damage sketch. It illustrates the addition of a 'Gusset' (a horizontal plate) and a 'Bulb plate stiffener' (a vertical plate) to reinforce the structure. Arrows point to these new components. Text above the diagram states: 'Continuous or intercostal reinforcement in line with flanges or gussets where not already fitted'. Text below the diagram states: 'Adjacent to the topside tank either a gusset to a bulb plate stiffener may be'. A label 'Bulb plate stiffener' points to the vertical reinforcement, and 'Gusset(similar gusset on the opposite' points to the horizontal reinforcement.</p>

Notes on possible cause of damage		Notes on repairs
<ol style="list-style-type: none"> 1. Damage due to poor design and/or defective welds. 		<ol style="list-style-type: none"> 1. Fractures may be veed-out and rewelded. If necessary corrugated plating cropped and renewed. 2. It is recommended that reinforcement as shown above be incorporated, giving due consideration to the following criteria: <ol style="list-style-type: none"> 2.1 It is important to have the gusset plates well aligned with the transverse structure inside the tank. Gusset plates may be joggled to obtain this alignment. 2.2 If there is no transverse web already existing inside the topside tank and in line with the flanges of corrugation or gusset plates, reinforcement as shown above to be fitted.

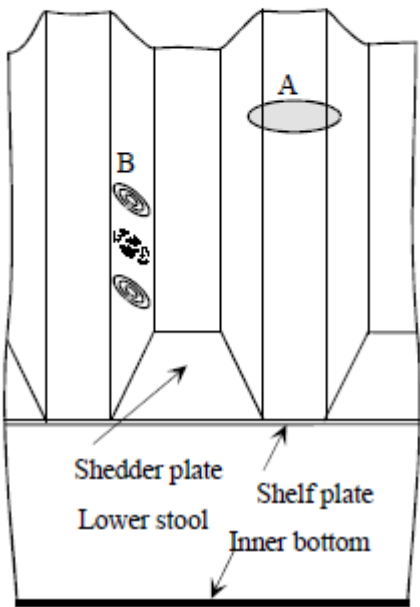
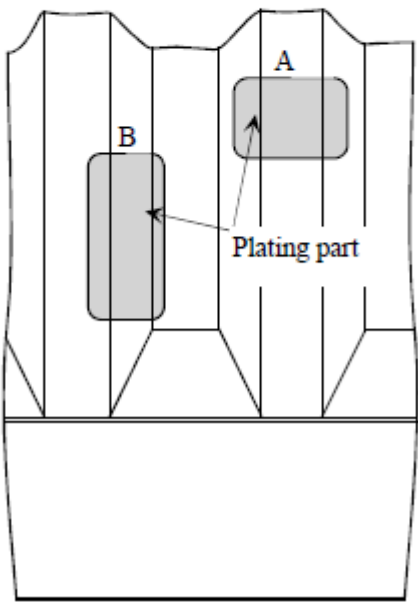
BULK CARRIERS		Guidelines for Surveys, Assessment and Repair of Hull Structure
Part 1	Cargo hold region	Example No.
Area 4	Transverse bulkhead and associated structure in cargo hold	3
Detail of damage		Indentation and buckling of vertical corrugation
Sketch of damage		Sketch of repair

Notes on possible cause of damage		Notes on repairs
<ol style="list-style-type: none"> 1. Damages by mechanical abuse during cargo handling e.g. grab damage. 2. Damage resulting from thickness reduction by corrosion. 3. Buckling caused by bending or shear, see locations A and B respectively above, with a minimum reduction in thickness could be caused by underdesign or overloading. If this cause is suspected, the Classification Society concerned shall be contacted before proceeding with repairs. 		<ol style="list-style-type: none"> 1. Damage by mechanical abuse If the indentation/buckling is local and of a minor nature, the plating can be faired in place. If the deformation is more pronounced and/or in association with a generalized reduction in thickness the plating is to be cropped and renewed, as shown at locations A and B above. 2. Damage resulting from corrosion In this case thickness measurements are to be taken at mid-span and top and bottom of corrugations, and corrugations renewed or part renewed as necessary. Particular attention is to be given to the fit and alignment at corners of flanged corrugations when being partly renewed.

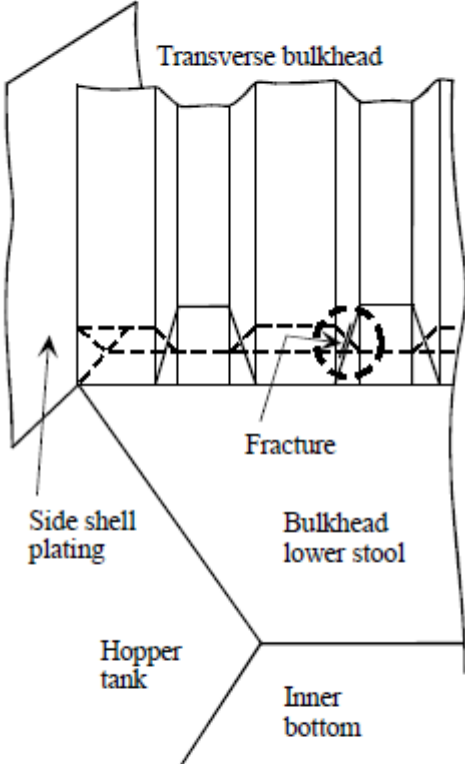
<p>Transverse bulkhead</p> <p>Fracture</p> <p>Side shell plating</p> <p>Bulkhead lower stool</p> <p>Hopper tank</p> <p>Inner bottom</p>

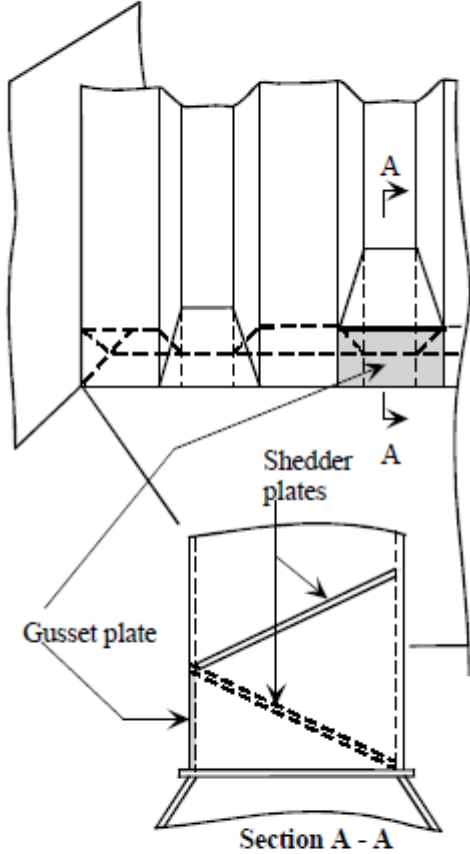
<p>Shedder plates</p> <p>Gusset plate</p> <p>Section A - A</p>
Notes on possible cause of damage		Notes on repairs
<ol style="list-style-type: none"> 1. Damage due to stress concentrations at intersection of shedder plates. This can be exacerbated by corrosion and reduction in thickness of the corrugation web plating. 		<ol style="list-style-type: none"> 1. If due to wastage, corrugation plating and shedder plates to be part renewed/renewed as necessary. 2. Where renewals are being carried out it may be prudent to fit the extension pieces shown above to change the location of the point of intersection, and hence reduce the stress concentration.

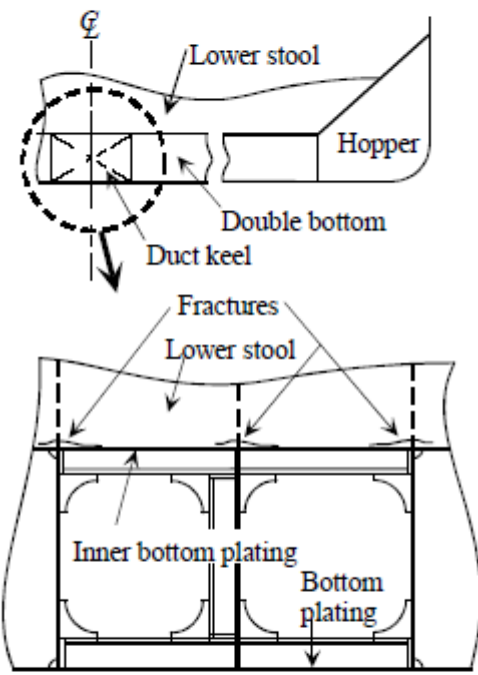
<p>Lower stool: Insert plate of increased</p> <p>Inner bottom plating: It may be necessary to crop and insert plating of enhanced grade</p>

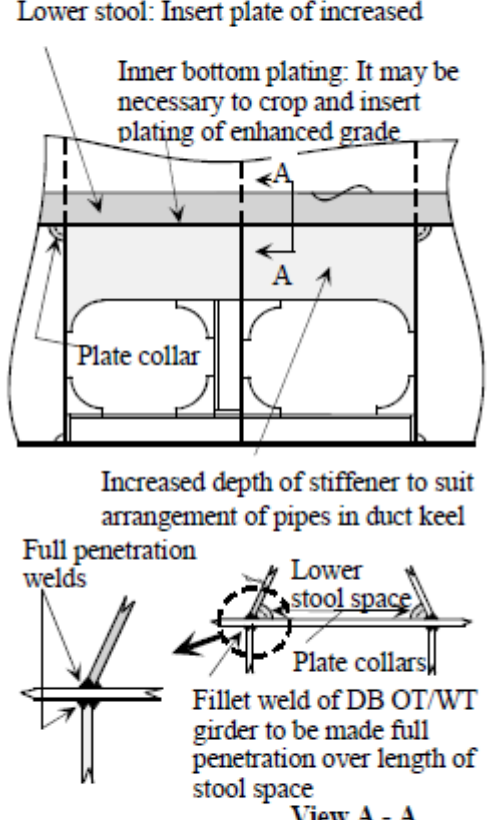
<p>View A - A</p>
Notes on possible cause of damage		Notes on repairs
<ol style="list-style-type: none"> 1. This type of failure is more likely to occur at the boundaries of the ballast hold. 2. The fractures arise because of stress concentration in way of cut-outs and exacerbated by the flexibility of the inner bottom structure in way of the duct keel. 		<ol style="list-style-type: none"> 1. In order to prevent recurrence of the damage, the additional reinforcement shown should be fitted.

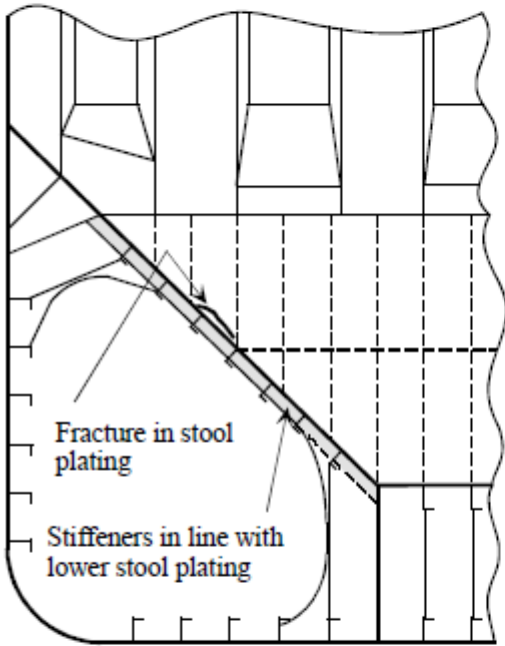
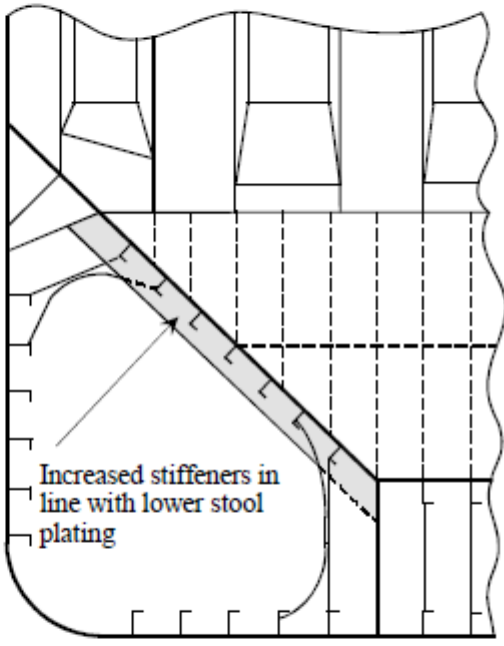
BULK CARRIERS		Guidelines for Surveys, Assessment and Repair of Hull Structure
Part 1	Cargo hold region	Example No.
Area 4	Transverse bulkhead and associated structure in cargo hold	6
Detail of damage		Fractures at the connection of lower stool to hopper
Sketch of damage		Sketch of repair

Notes on possible cause of damage		Notes on repairs
<ol style="list-style-type: none"> 1. Insufficient strength of the connection 2. Corrosion 		<ol style="list-style-type: none"> 1. Fractured stool plating should be partly cropped and renewed (thicker plate) if considered necessary. 2. If the damage occurred due to insufficient strength, stiffeners in line with stool plating should be increased.

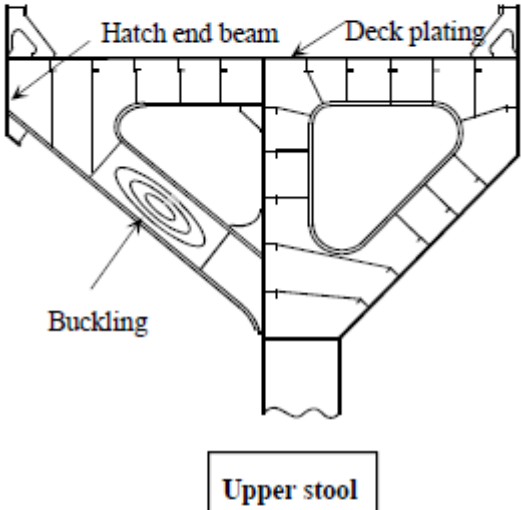
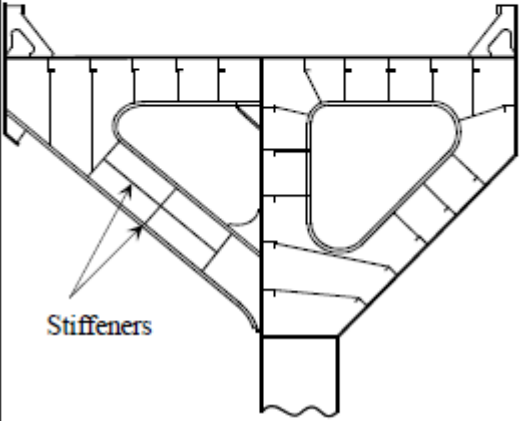
BULK CARRIERS		Guidelines for Surveys, Assessment and Repair of Hull Structure	
Part 1	Cargo hold region	Example No.	
Area 4	Transverse bulkhead and associated structure in cargo hold	7	
Detail of damage		Buckling of strut supporting hatch end beam	
Sketch of damage		Sketch of repair

Notes on possible cause of damage		Notes on repairs	
<ol style="list-style-type: none"> 1. Insufficient strength 2. Partial ballast loading in ballast cargo hold (sloshing) 3. Corrosion 		<ol style="list-style-type: none"> 1. Deformed part to be cropped and renewed if considered necessary. 2. If the damage occurred due to insufficient strength, appropriate reinforcement is to be considered (thicker plate/additional stiffener(s)).

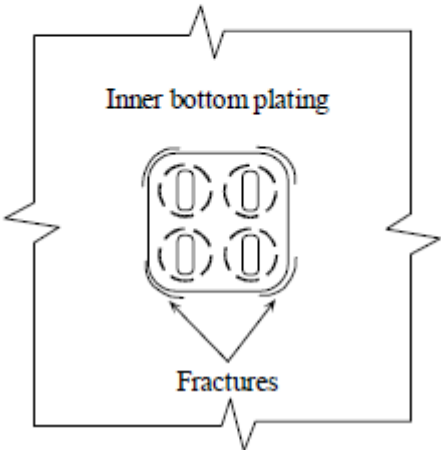
BULK CARRIERS		Guidelines for Surveys, Assessment and Repair of Hull Structure
Part 1	Cargo hold region	Example No.
Area 5	Double bottom structure including hopper	1
Detail of damage Fractures in inner bottom plating around container bottom pocket		
Sketch of damage		Sketch of repair

<p>Most common repair</p>

Notes on possible cause of damage		Notes on repairs
1. Pocket is not supported correctly by floor, longitudinal and/or stiffener.		1. Fractured plating should be cropped and part renewed. 2. Adequate reinforcement should be considered.

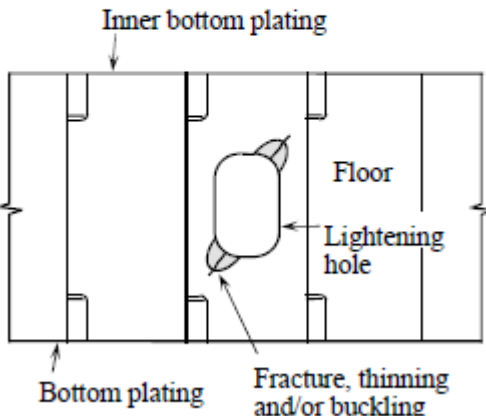
BULK CARRIERS		Guidelines for Surveys, Assessment and Repair of Hull Structure	
Part 1	Cargo hold region	Example No.	
Area 5	Double bottom structure including hopper	2	
Detail of damage		Fractures, corrosion and/or buckling of floor/girder around lightening hole	
Sketch of damage

Notes on possible cause of damage 1. Insufficient strength due to lightening hole. 2. Fracture, corrosion and/or buckling around lightening hole due to high stress.		Notes on repairs 1. Fractured, corroded and/or buckled plating should be cropped and renewed if considered necessary. 2. Appropriate reinforcement should be considered.

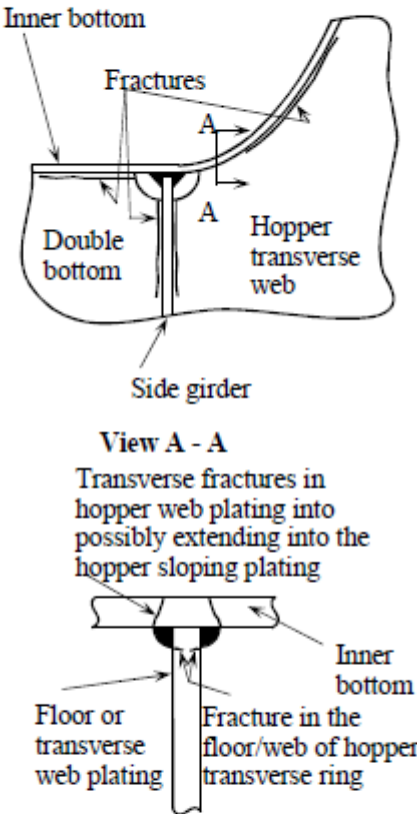
BULK CARRIERS		Guidelines for Surveys, Assessment and Repair of Hull Structure
Part 1	Cargo hold region	Example No.
Area 5	Double bottom tank structure including hopper	3
Detail of damage	Fractures at weld connections of floors in way of hopper/inner bottom interface (radiused knuckle)	
Sketch of damage

<p>View A - A Transverse fractures in hopper web plating into possibly extending into the hopper sloping plating</p> <p>Fracture in the floor/web of hopper transverse ring</p>		Sketch of repair

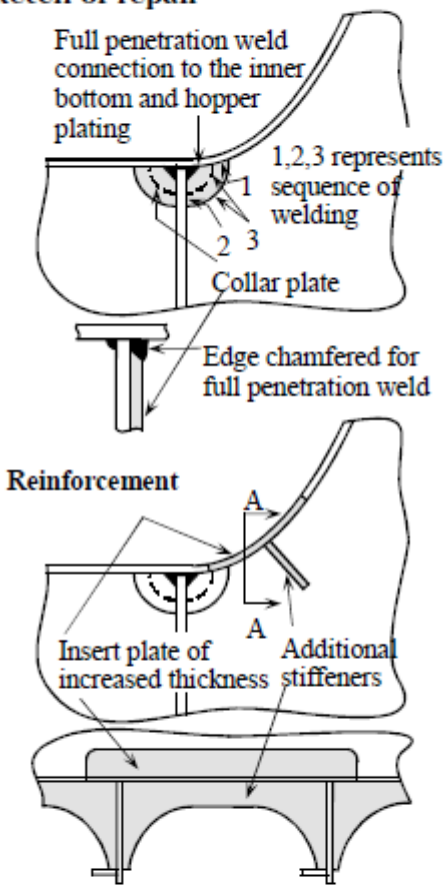
<p>Full penetration weld connection to the inner bottom and hopper plating</p> <p>1,2,3 represents sequence of welding</p> <p>Collar plate</p> <p>Edge chamfered for full penetration weld</p> <p>Reinforcement</p> <p>Insert plate of increased thickness</p> <p>Additional stiffeners</p>
Notes on possible cause of damage 1. The damage is partly due to stress concentrations at the edges of the weld created by the presence of cut-outs and local stress variations caused by the deflections in the inner bottom/hopper plating.		Notes on repairs 1. The fracture in the weld and/or plating is veed-out/cropped and renewed as appropriate. 2. The cut-outs are eliminated by introducing suitable collar plate with emphasis on edge preparation and sequence of welding as shown above. 3. Further reinforcements may need to be carried out as shown above, however, after consultation with the Classification Society concerned.
